**BRIDGE CONDITION REPORT
STRUCTURE NUMBER 027-0040**

FINAL REPORT

FAP ROUTE 798
SECTION 107BR-1
FORD COUNTY
P-93-064-02

ILLINOIS ROUTE 115
OVER DRAINAGE DITCH

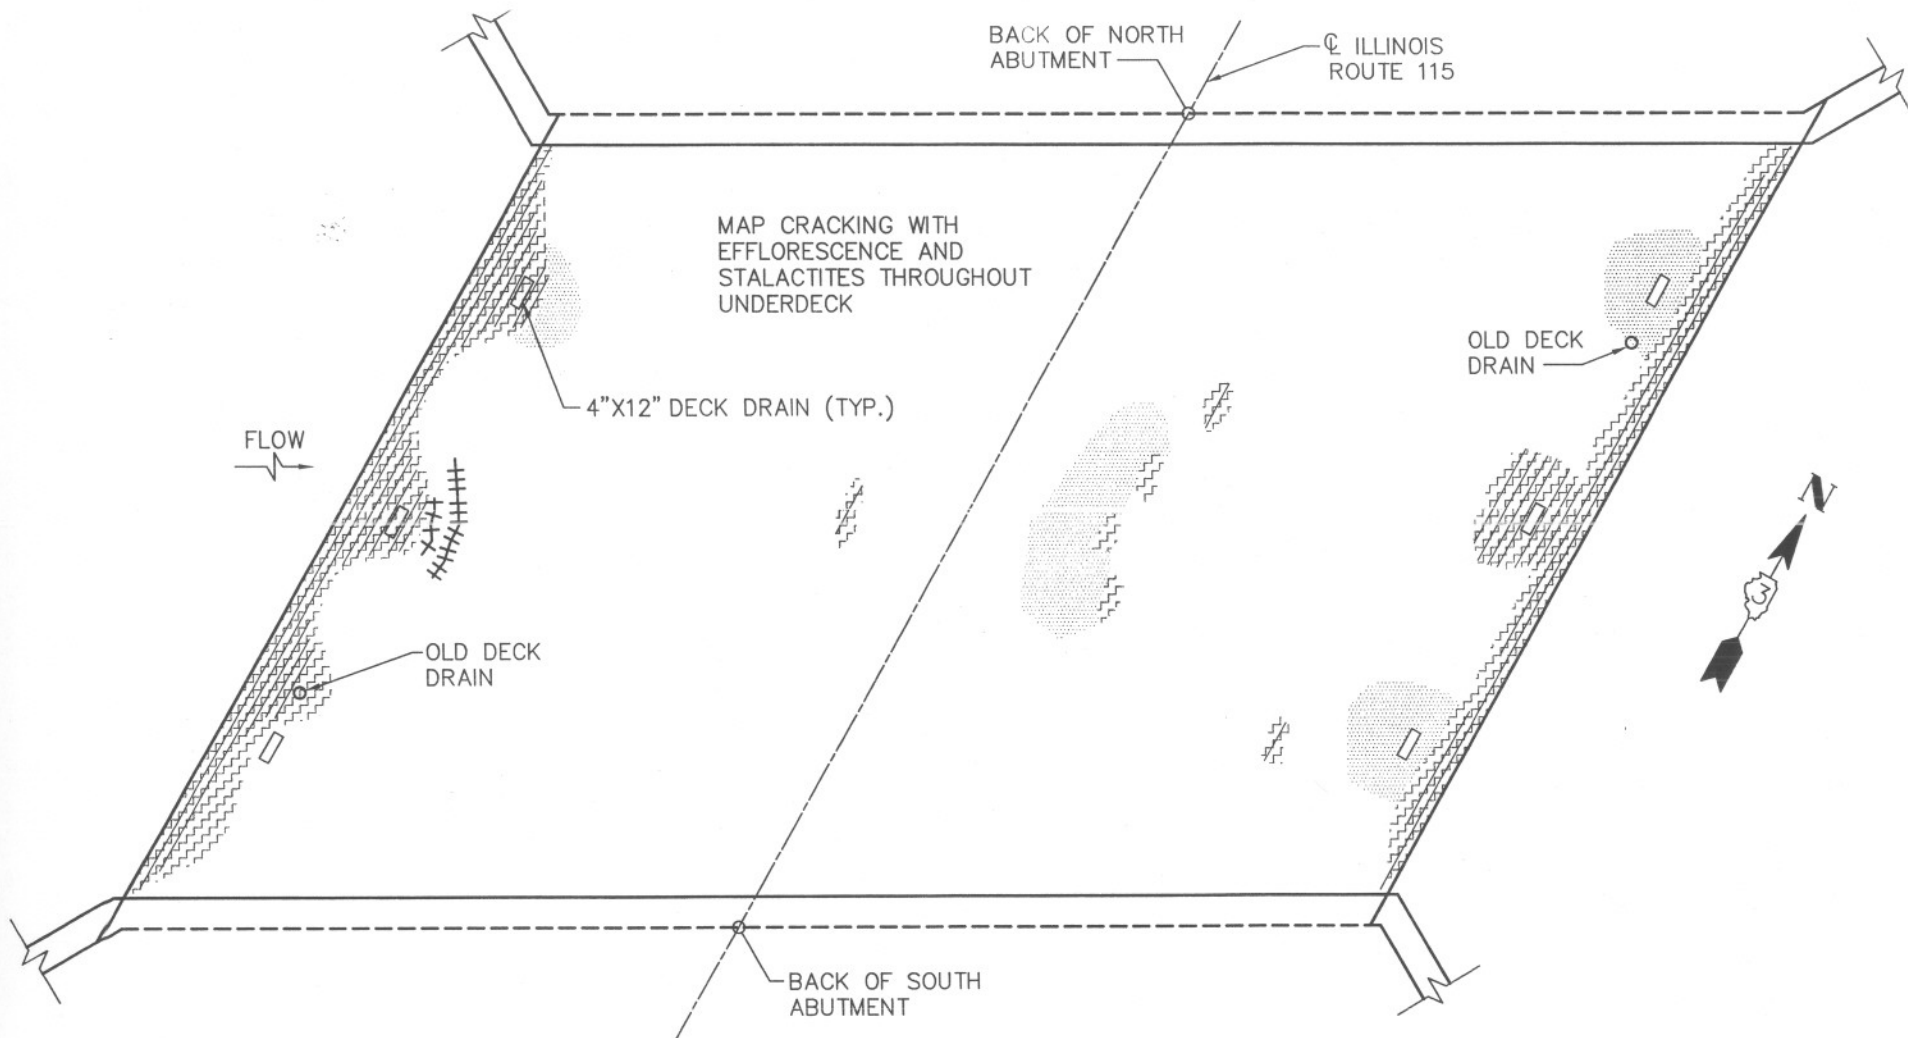
BOTTOM OF DECK
 $\frac{1}{4}" = 1' - 0"$

The underdeck is in poor condition. The surface is moist with efflorescence and rust stains, stalactites, tight map cracking and spalling with exposed reinforcement. Most of the spalling is isolated along the sides of the deck and around the deck drains. Efflorescence staining with stalactites occurs throughout the underdeck, which indicates the entire deck is saturated with salts.

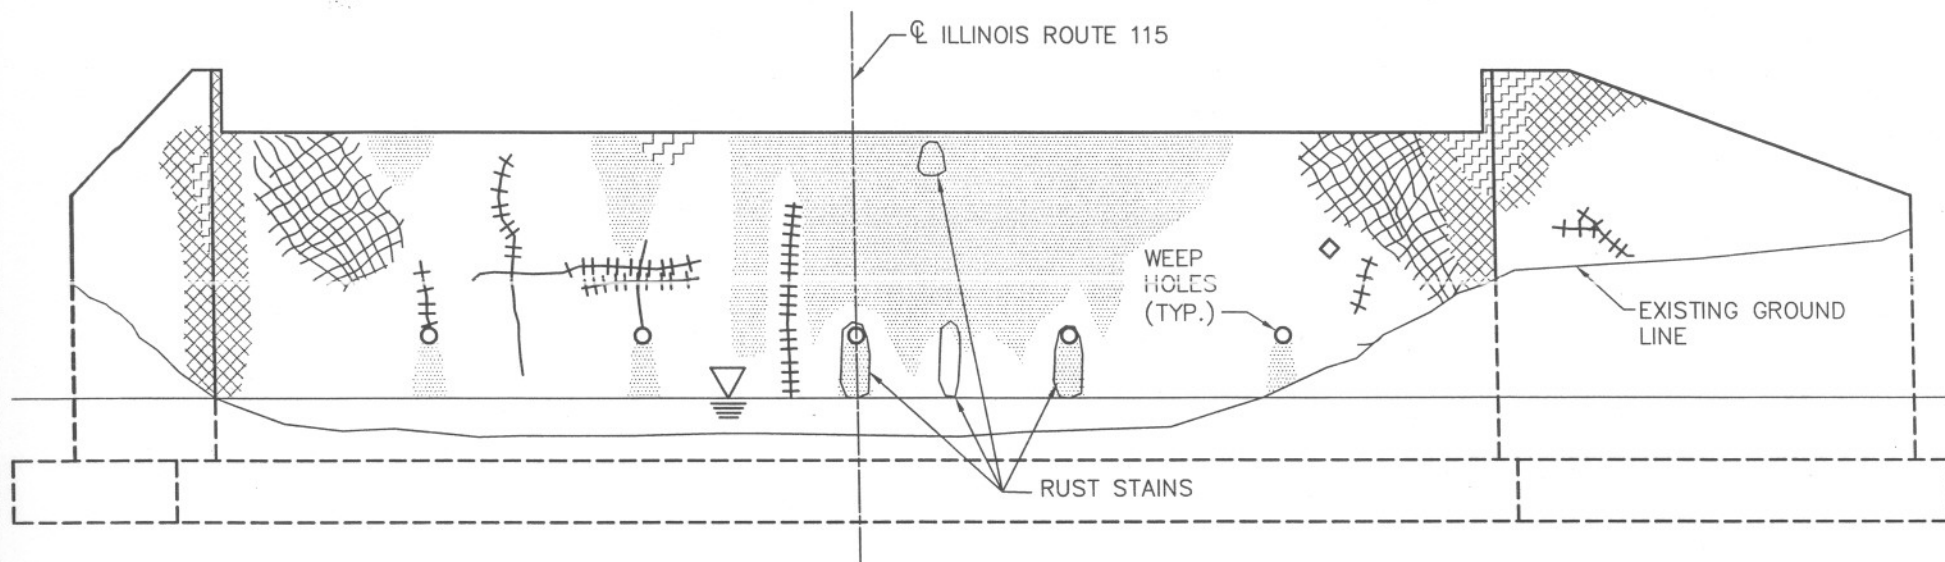
NORTH ABUTMENT AND WINGWALL ELEVATIONS

The abutment walls are in fair to poor condition with areas of map cracking, horizontal cracks with efflorescence, spalling at the wingwall corners and hollow areas near the top of the walls. Both abutment walls have significant moisture and efflorescence staining along the front face due to leaking of the top joint. The wingwalls are in fair condition with some cracks with efflorescence, spalling and a few hollow areas.

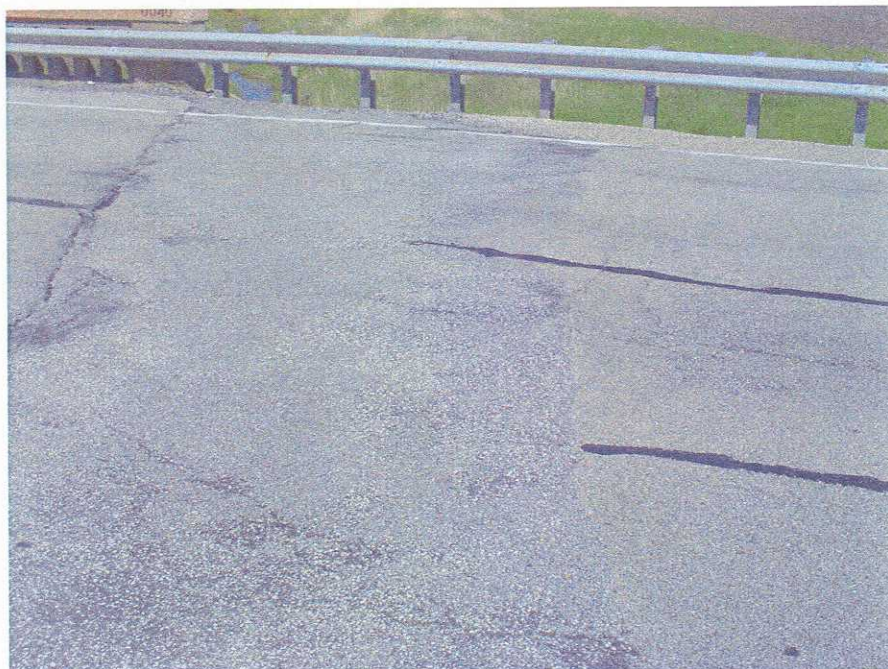
The approach roadway is in fair condition. Reflective cracks in the bituminous surface are forming in the pavement. Slight rutting is occurring in the wheel lanes along the overlay. The reflective cracks have been recently sealed. Bituminous patching/filling along the south abutment indicates the approach pavement is failing.

SOUTH APPROACH PAVEMENT PATCH

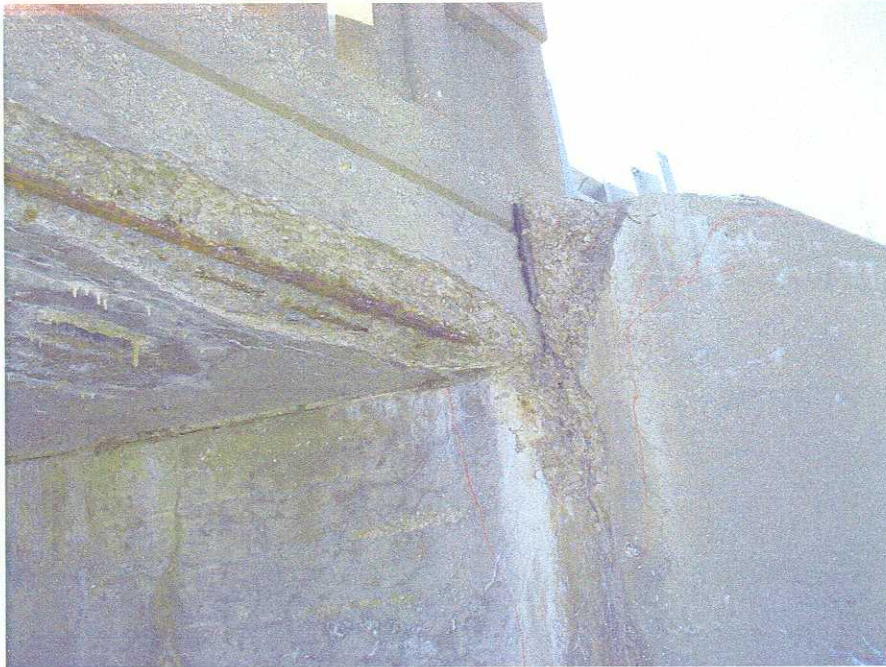
SPALLING AT NORTHEAST WINGWALL AND FASCIA

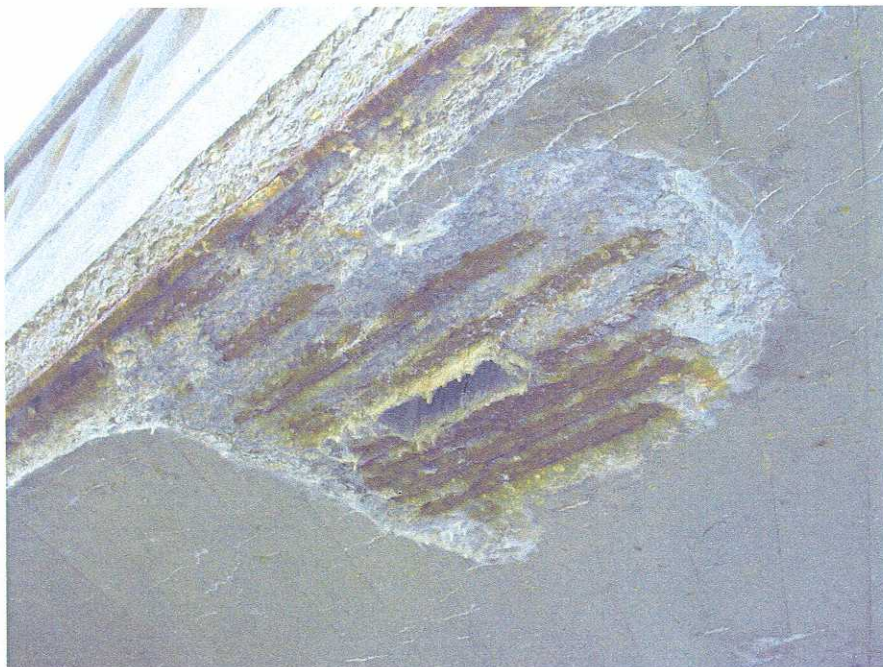
TYPICAL SPALLING AROUND DECK DRAINS

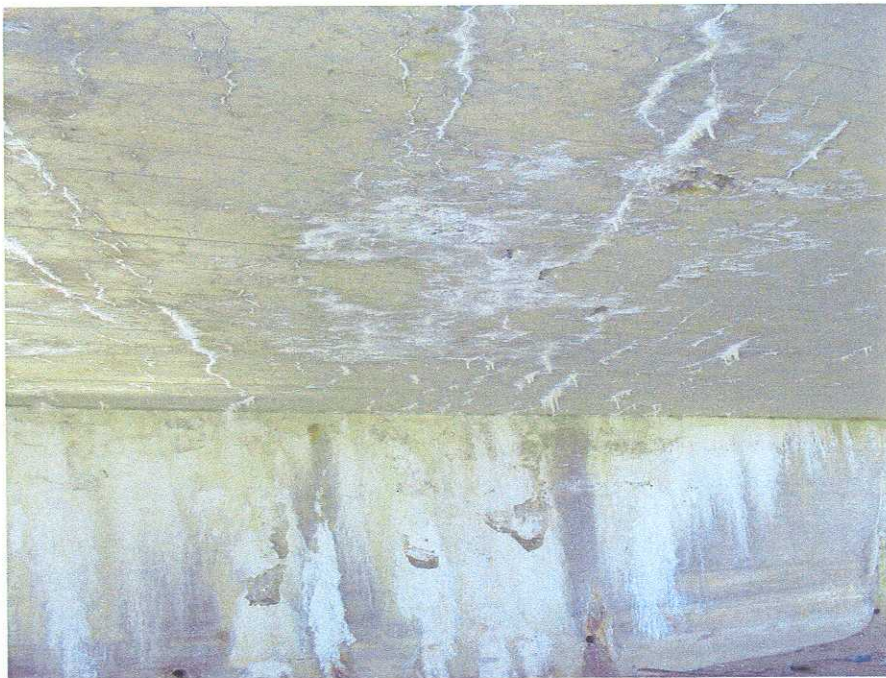
TYPICAL SPALL AND MAP CRACKING WITH
EFFLORESCENCE IN UNDERDECK

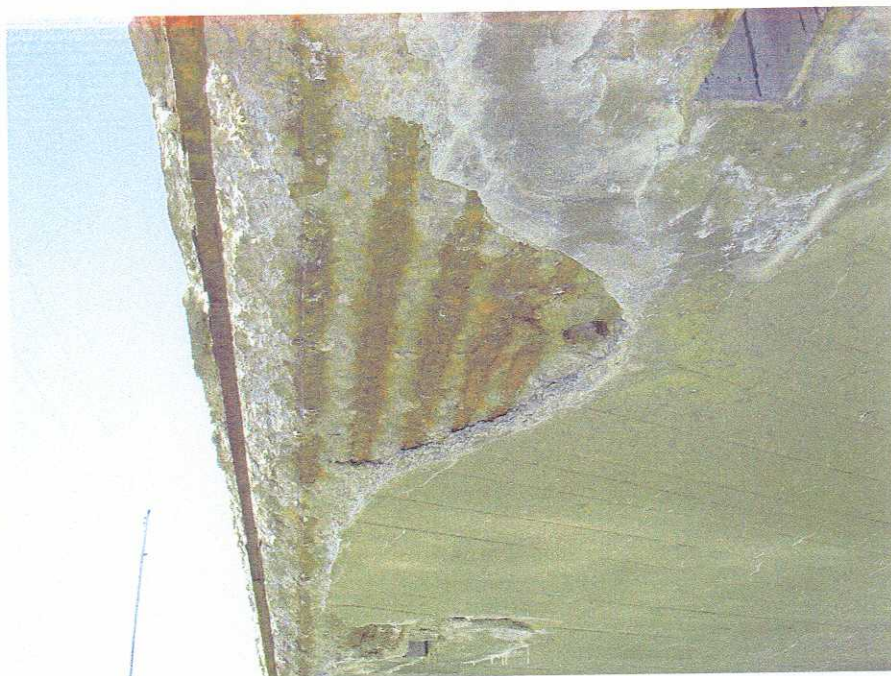
SPALL ON WEST FASCIA AND UNDERDECK

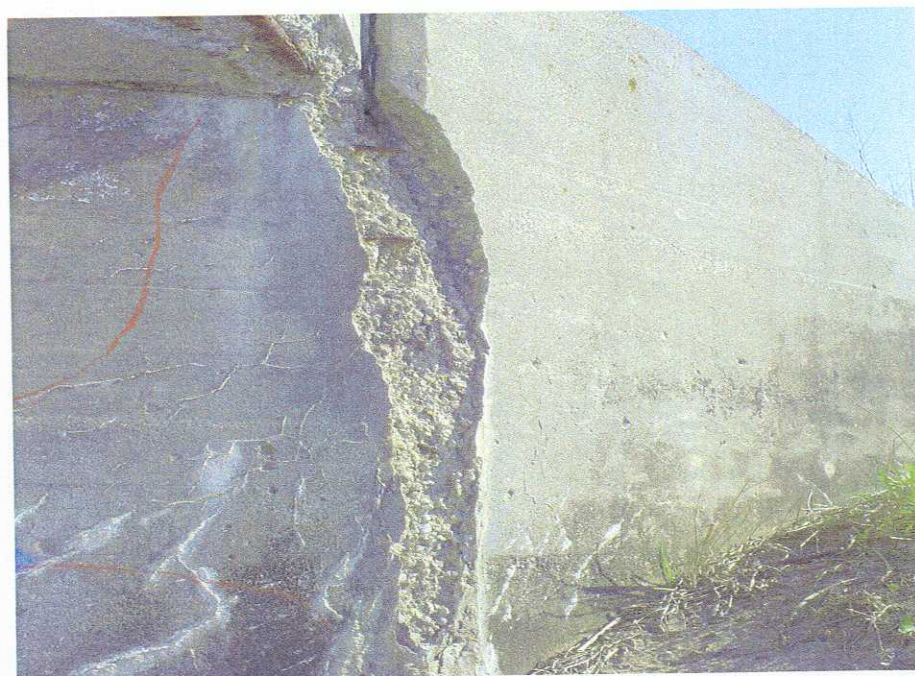
SPALL ON SOUTH EAST WINGWALL / ABUTMENT

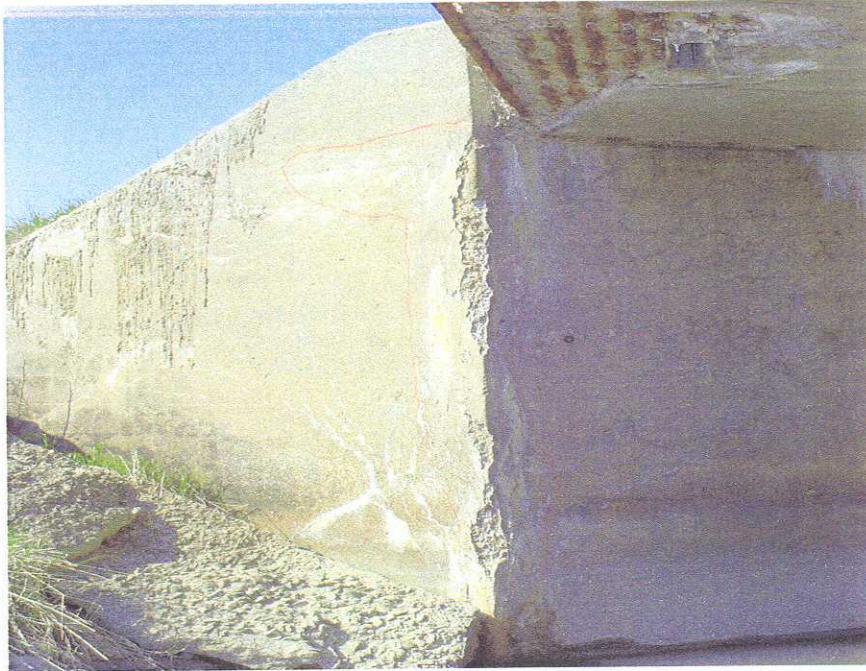
SPALL AND HOLLOW AREA ON NORTHEAST WINGWALL
